# Salt Lake City Riparian Corridor Study

## Final Red Butte Creek Management Plan

February 2010

BIO-WEST Project No. 1198

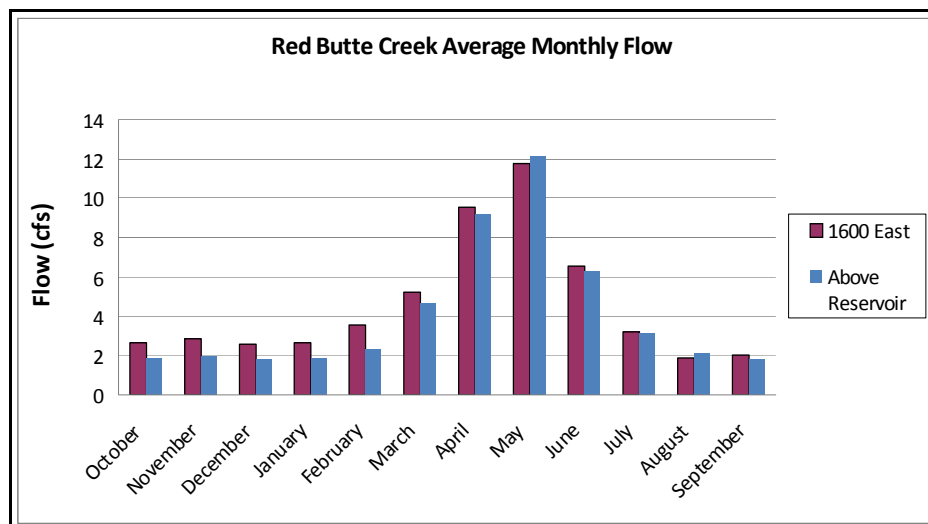
**Figure 3.3.** Monthly flows at Salt Lake County’s gage at 1600 East and the U.S. Geological Survey gage above Red Butte Reservoir.

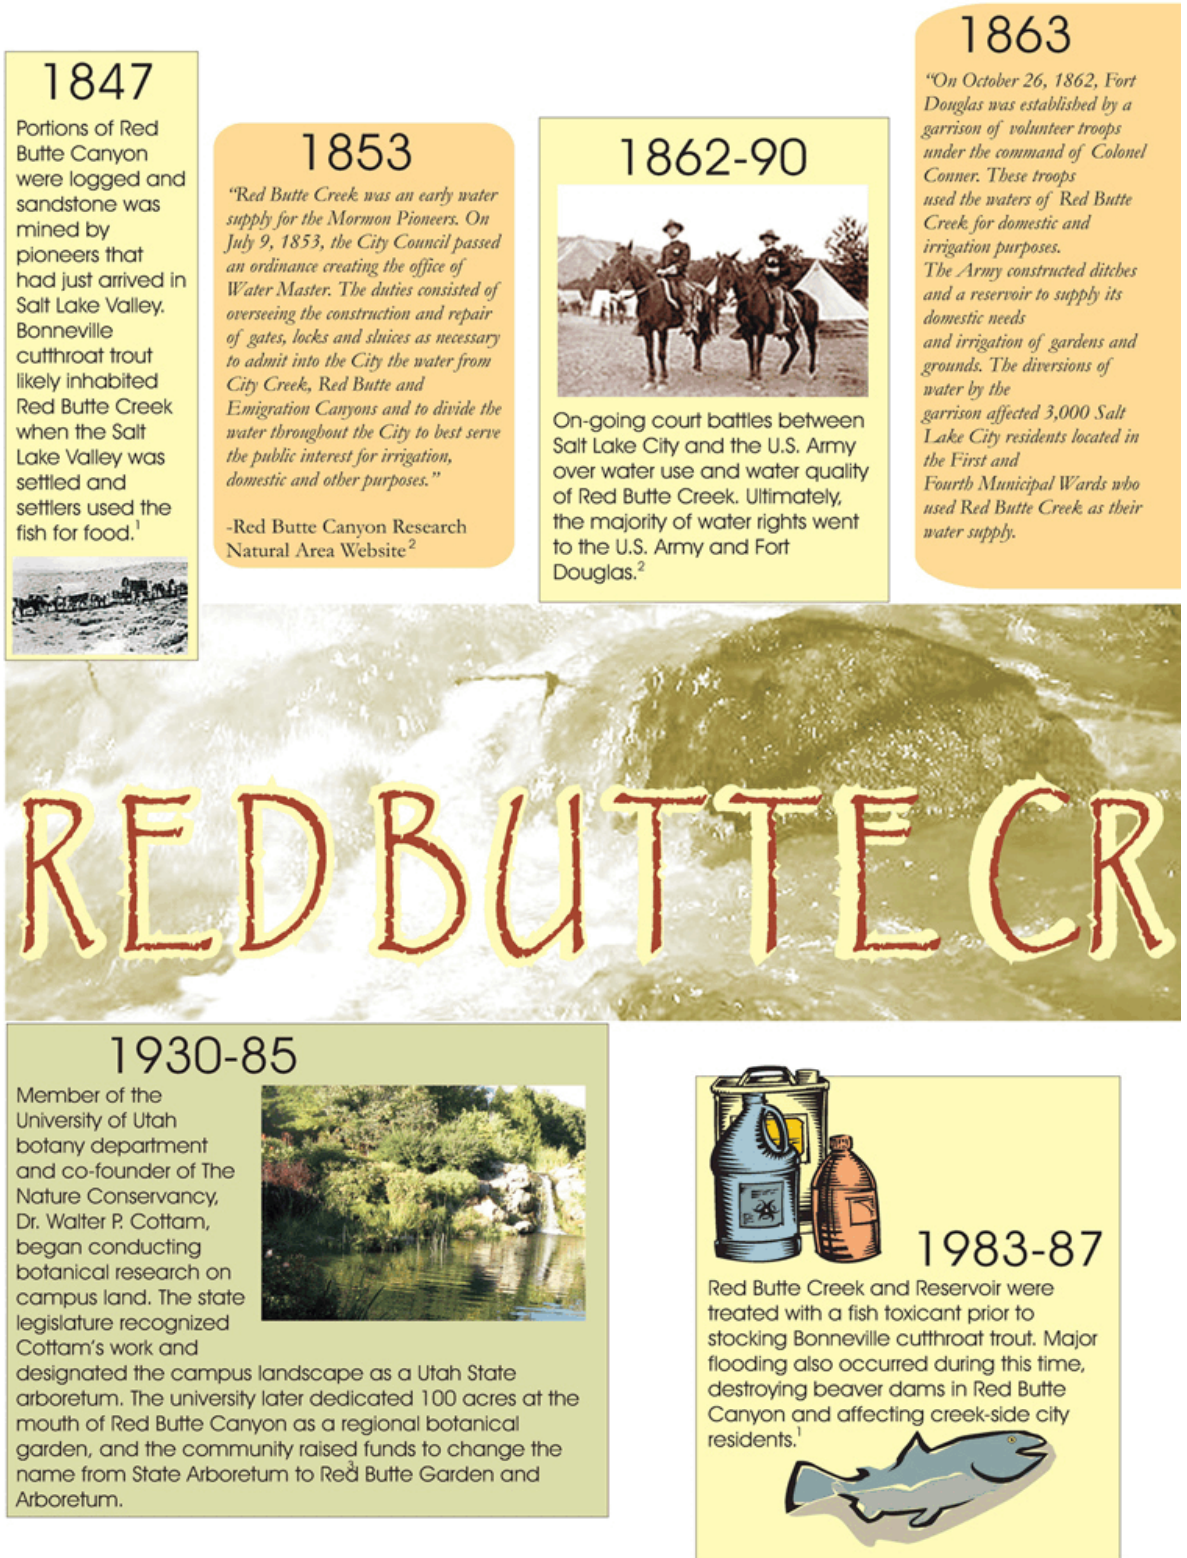
Figure 3.6. Red Butte Creek historical timeline.

When Fort Douglas was established by the U.S. Army in 1862, conflicts arose with Salt Lake City over the use and quality of the Red Butte Creek water supply (Figure 3.6). The upper Red Butte Creek watershed has been under Federal ownership and protection since about 1900, and today functions as a USFS Research Natural Area (Red Butte Canyon RNA 2009). Because of this history of protection, the upper watershed remains in a relatively pristine condition.

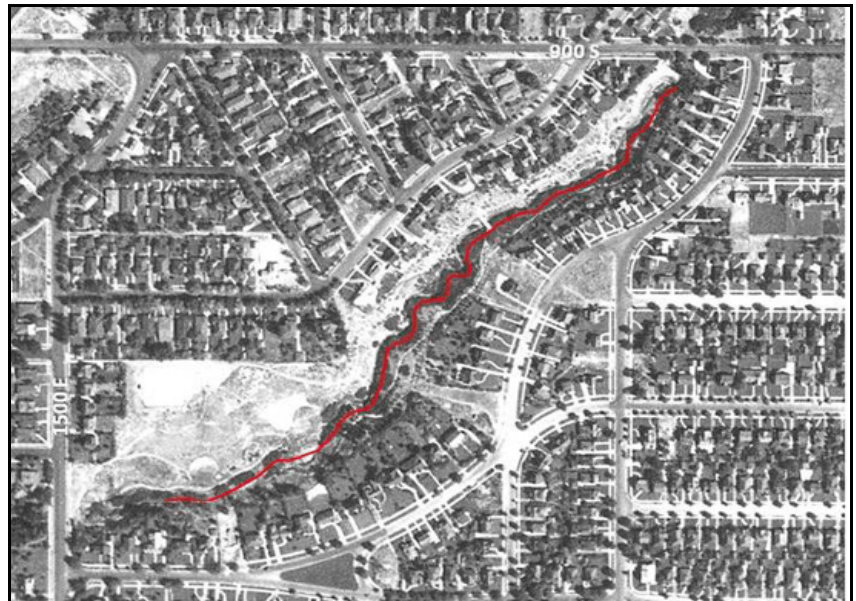
**Figure 3.7.** 1938 aerial photograph of Red Butte Creek from 900 South to 1500 East. Photograph is overlaid with 2006 channel alignment in red; gaps in line indicate underground culverts.

In general, the channel alignment of Red Butte Creek does not appear to have changed dramatically since 1938. Some relatively minor bend straightening is evident in portions of the channel within the areas that are now Bonneville Glen and Sunnyside Park (Figures 3.7 and 3.8 ). Another significant change since 1938 has been an increase in length and number of culvert pipes. Near 1500 East, approximately 300 feet of what used to be open stream channel (Bowman and Beisner 2008) is now piped under a parking lot (Figure 3.7). Similarly, just downstream from Foothill Drive, approximately 130 feet of what was once forested stream channel is now piped under a road crossing (Figure 3.8). The construction of culvert crossings and the piping of portions of Red Butte Creek facilitated urban growth but also reduced total channel length, resulting in greater channel slope and higher stream velocities. The culverts have also disrupted the connectivity of the riparian corridor by creating barriers to fish and wildlife migration.

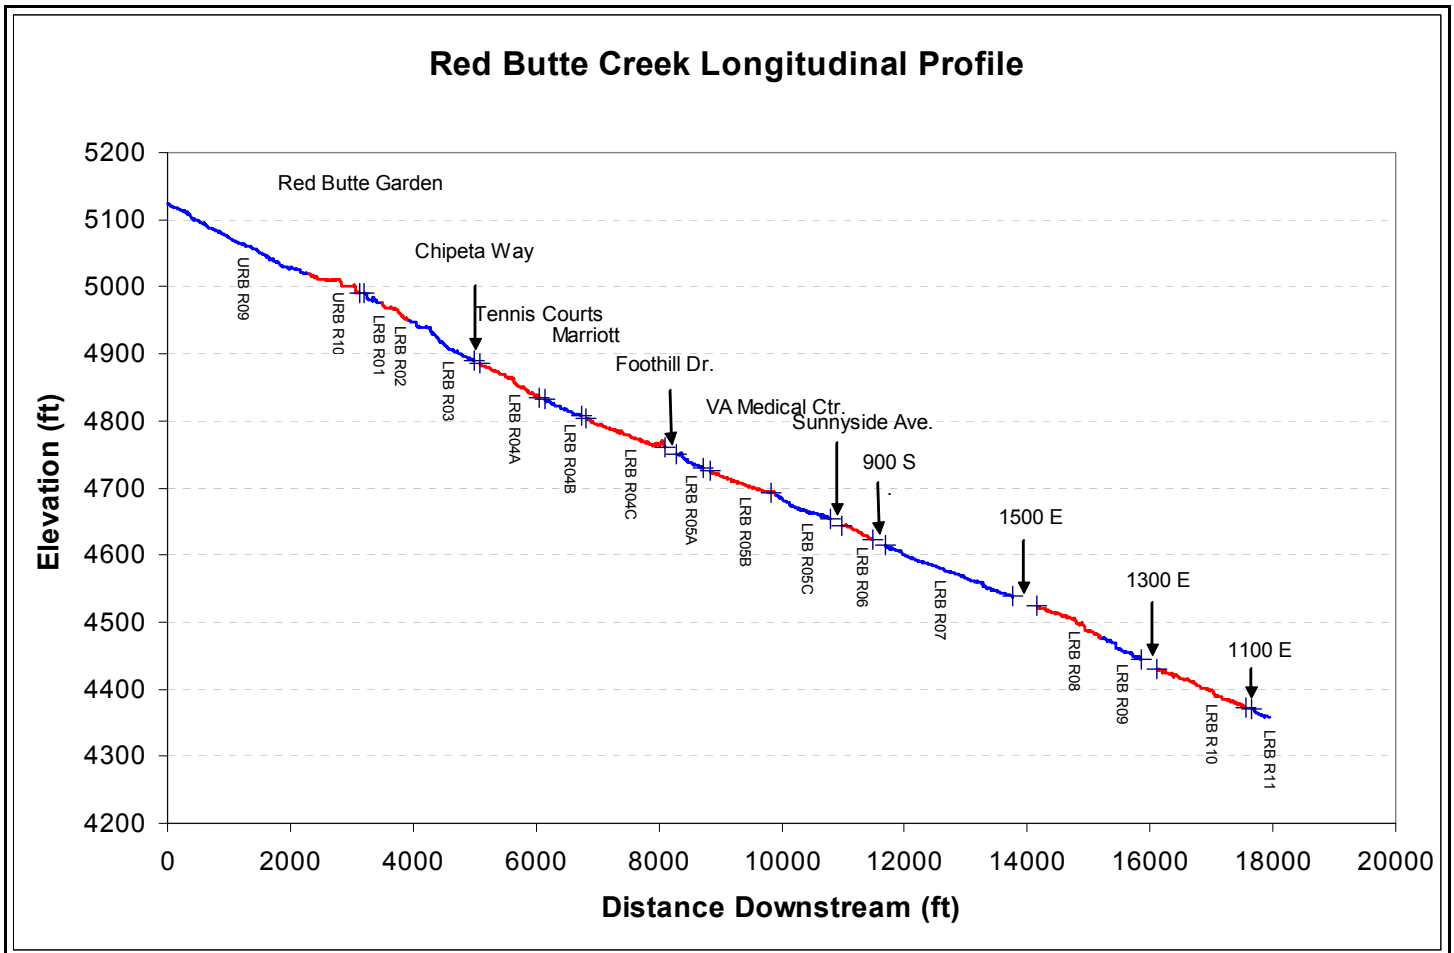
**Figure 3.11. Longitudinal profile plot of Red Butte Creek streambed. Black cross marks indicate culvert inlets or outlets; red and blue lines indicate open channel stream sections.**

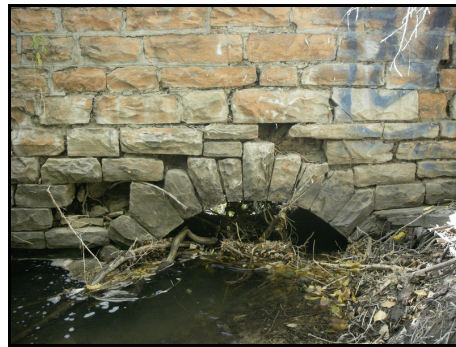
**Top left: Debris and sediment accumulation at culvert inlet. Top right: Erosion at storm drain outfall. Bottom left: Invasive vines on streambank. Bottom right: Scour at culvert outlet.**

Erosion was commonly observed at storm drain pipe outfalls within the study area. These outfalls deliver storm water runoff to the creek from streets, gutters, and

rooftops. The outfalls often lack adequate outlet protection to dissipate runoff velocities and protect against erosion. Even where outlet protection is provided, stabilized conveyance channels are typically lacking between the protected outlet and the main Red Butte Creek channel and evidence of rill erosion in these areas is common. Of the 25 mapped outfall locations, 12 were ranked as medium- or high-priority areas for stability improvements.

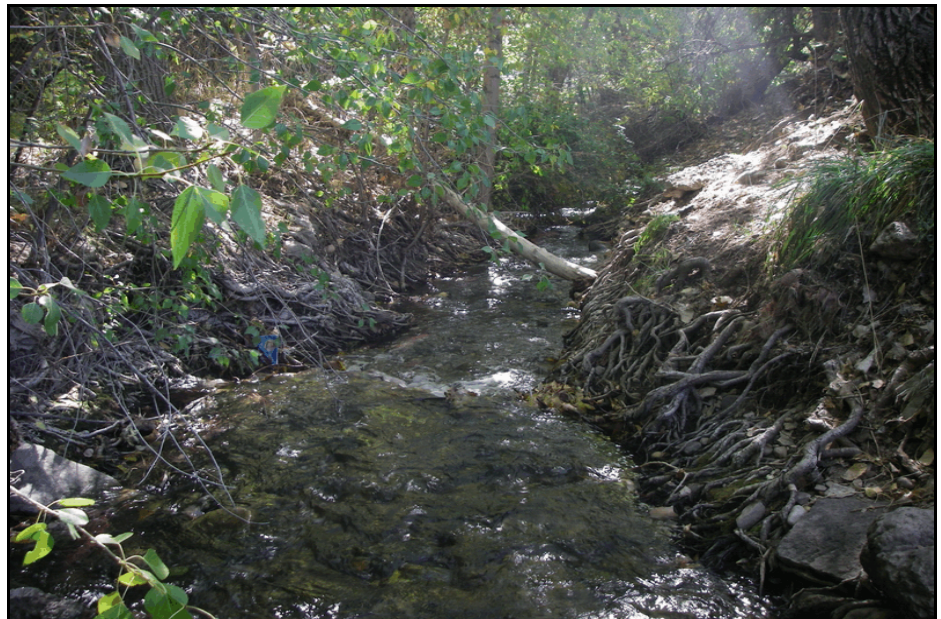
**Top: Terrace erosion at outside of bend. Bottom: Low bank/root zone erosion.**

Several types of bank erosion were observed in the study area. Low bank erosion/root zone scour are evident in nearly all study reaches and are associated with the flashy urban hydrology that produces frequent, erosive runoff events during storms. In some areas, it appears that streambed lowering is also contributing to low bank erosion by causing the toe of the slope to become undermined. In some reaches tall, vertical, bare banks are present where the creek has migrated laterally into a fine-grained Bonneville terrace deposit. This type of terrace erosion at the outside of bends is a natural process, but it is a concern where it poses a risk to infrastructure. Localized bank erosion caused by direct channel alterations is another type of

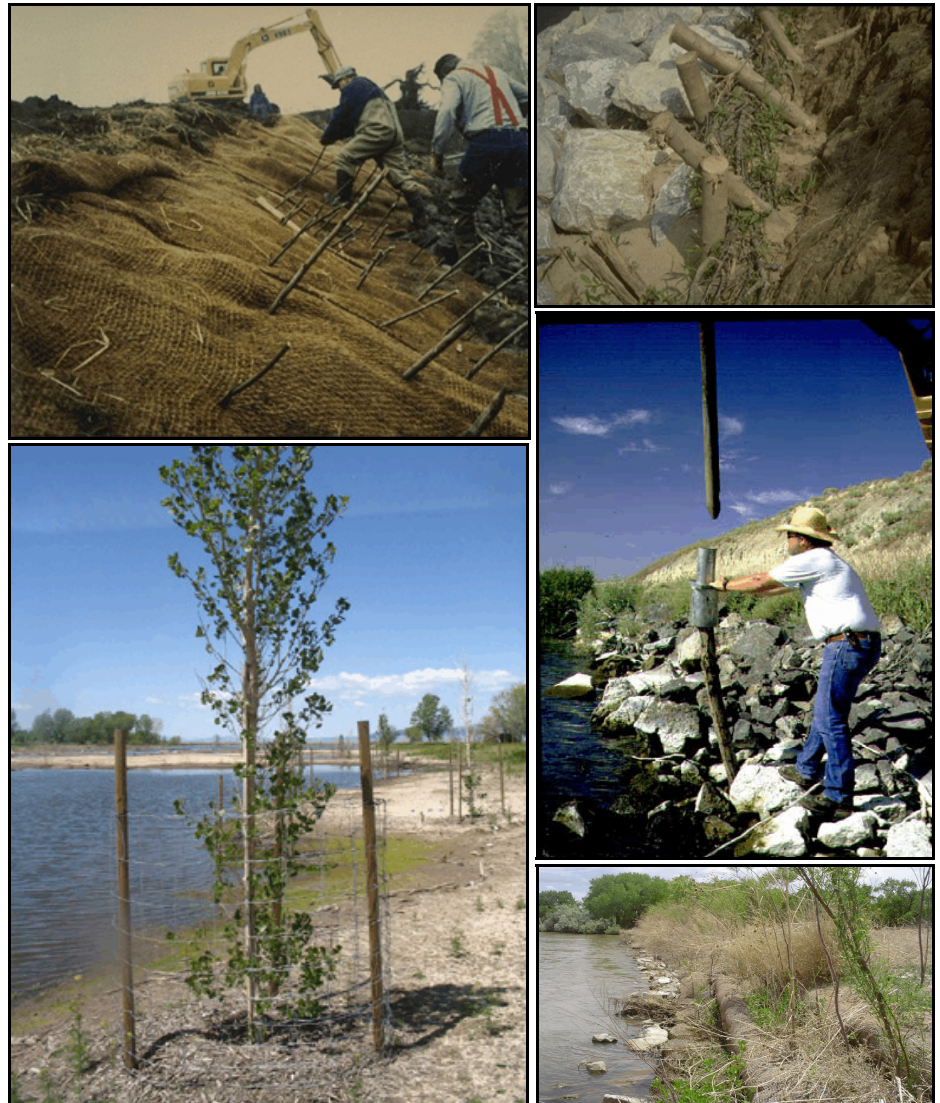
**Figure 4.4. Photographs of revegetation and biotechnical slope-stabilization techniques. (Top left: erosion-control blanket and live stakes [image from FISRWG 1998]. Top right: live pole plantings [image from FISRWG 1998]. Bottom left: containerized cottonwood (*Populus* sp.) planting protected from herbivory with wire mesh cage. Middle right: installation of live plant posts to create vegetated rock revetment [image from NRCS 2007]. Bottom right: vegetated soil lifts with live plant stakes and rock toe protection.)**

- vegetated soil lifts
- vegetated rock revetment using live stakes, pole plantings, and/or brush layering
- vegetated modular block retaining walls
- vegetated crib retaining walls
- vegetated gabion basket retaining walls

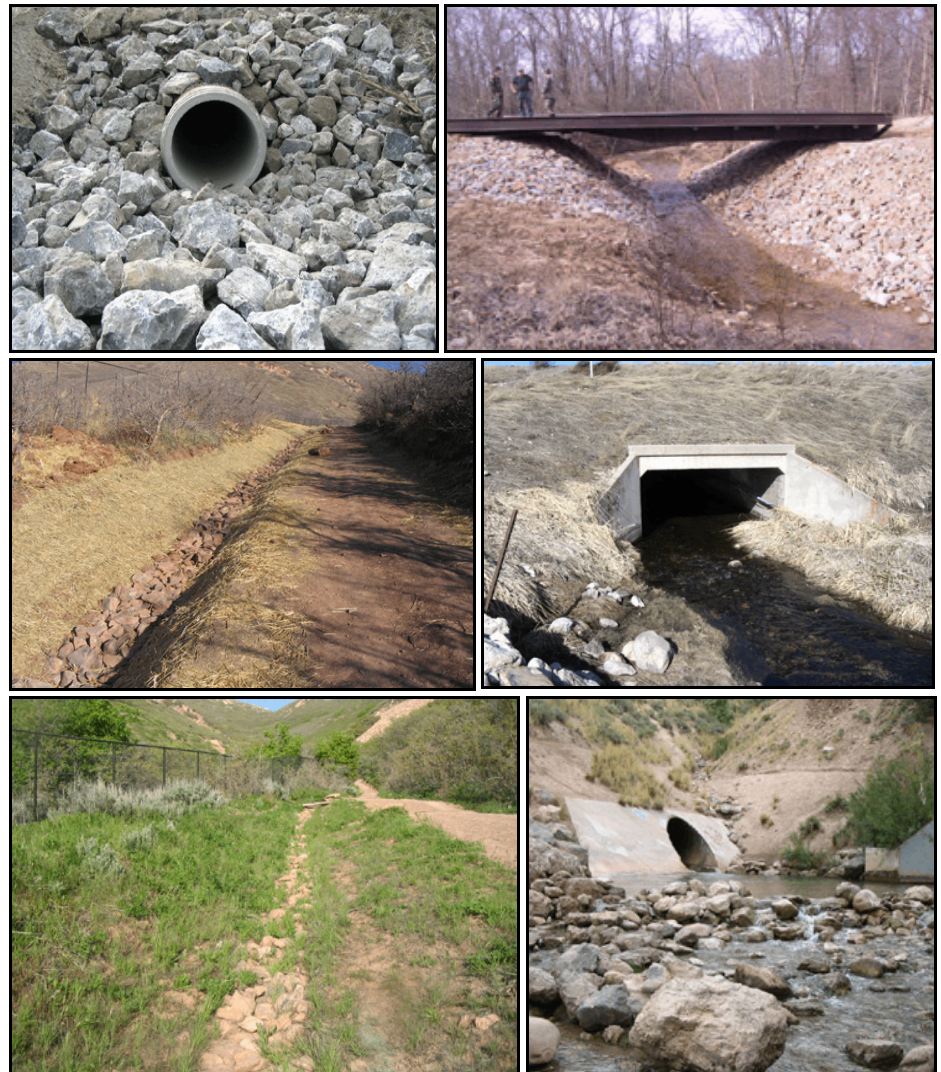
**Figure 4.5.** Photographs of outlet protection and stream crossing techniques. (Top left: rock outlet protection. Top right: stream crossing using a bridge made from a recycled railroad flatcar. Middle left: vegetated rock-lined swale immediately following construction. Middle right: stream crossing using an open-bottom box culvert. Bottom left: vegetated rock-lined swale in second growing season. Bottom right: tailwater pool at culvert outlet.)

The purpose of these recommended outlet protection measures is to reduce culvert outlet velocities, dissipate energy, create a stable streambed elevation that will not be susceptible to scour, and create stable streambanks adjacent to the culvert outlet. Culverts with especially high outlet velocities may require the installation of a series of step-pool features below the initial rock-lined tailwater pool to ensure a stable transition

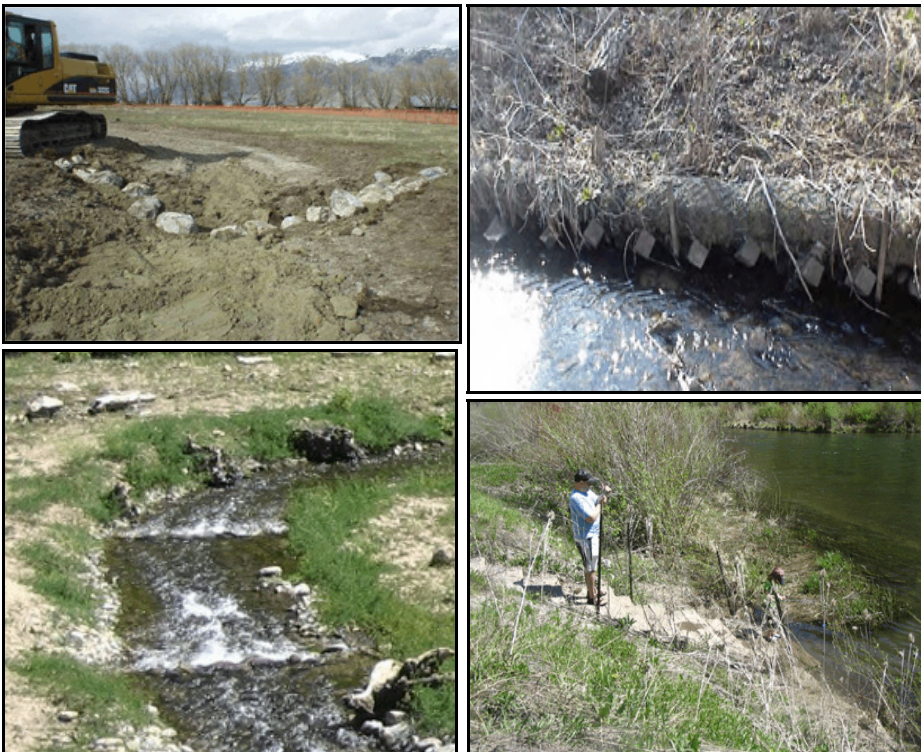
**Figure 4.6. Photographs of grade-control, bank-stabilization, and access-control techniques. (Top left: construction of a vortex rock weir. Top right: A-jacks toe protection [image from Schueler and Brown 2004]. Bottom left: downstream view of two vortex rock weir structures. Bottom right: steps that provide stabilized stream access.)**

The use of vortex rock weirs is recommended as the primary grade-control technique for the Red Butte Creek riparian corridor. These structures use two offset layers of immobile boulders arranged in a “V” shape to create a stable hard point in the streambed profile that will resist future scour. Photographs of vortex rock weirs are provided in Figure 4.6, and a detail

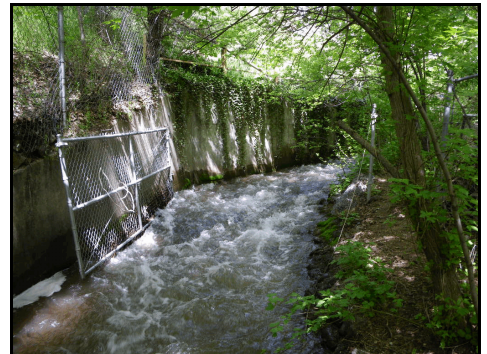
### Reach LRB R06: Sunnyside Avenue to 900 South

This reach flows through a privately owned residential area. Conditions were qualitatively evaluated from a property near the upstream end of the reach and also from the culvert inlet at the downstream end of the reach. Banks are steep in this reach, and the channel has been artificially stabilized in a number of areas with a variety of structures including boards, concrete walls, rock weirs, and gabion baskets. Understory vegetation is dominated by invasive English ivy and periwinkle vine. Whitetop, a noxious weed, was also noted as present in the reach. Opportunities are somewhat limited in this reach due to infrastructure constraints, but improvements to habitat and filtration functions could be attained through restoration of native understory plants and biotechnical stabilization of steep upper slope areas. Installation of stabilized, pervious access steps could also improve stability and reduce potential erosion in areas where access trails currently consist of bare dirt.

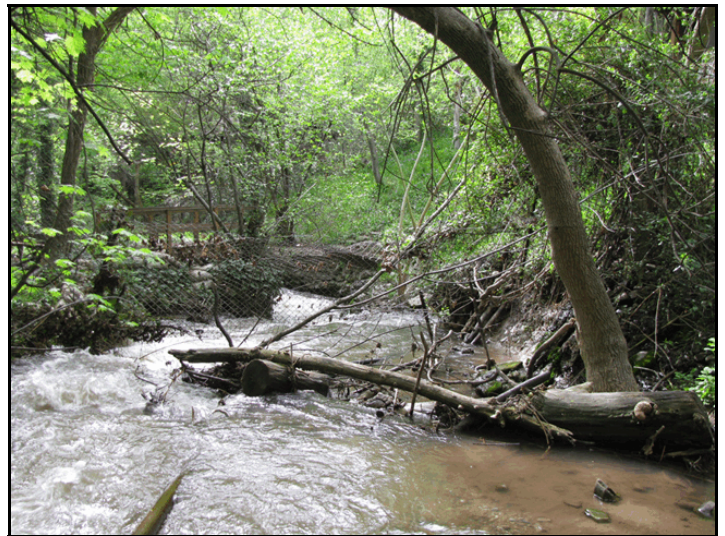
### **Reach LRB\_R09: Above 1300 East**

This reach was qualitatively evaluated from one property located near the middle of the reach. As in most of the study area, banks are steep and tall. The channel is well shaded by trees; understory vegetation is dominated by English ivy and periwinkle vine in some areas. Woody debris adds to in-channel habitat complexity. Streambanks have been hardened with grouted rock on some properties, and footbridges and fences occasionally cross the channel. Springs and seeps appear to be common in this reach and help to maintain baseflows while adding to habitat and vegetation diversity. Some of these springs have been developed with pipes and/or rock spring heads. In several areas within the reach, small cottages are present immediately adjacent to or directly above the stream channel. These historic structures were built to provide cool places to sleep during the summer. Recommended projects for this reach include restoration of native understory plants, biotechnical stabilization of upper slope areas, and replacement of dirt access trails with stable, pervious access steps.

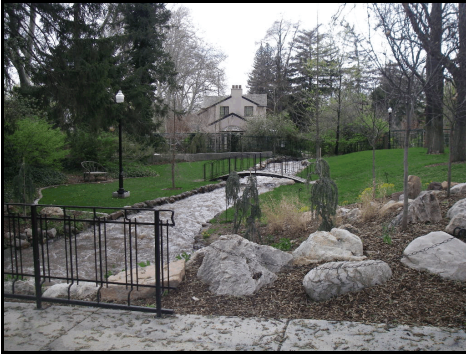
### [Reach LRB\\_R10: 1300 East to 1100 East \(cont.\)](#)

In this reach the Red Butte Creek channel drops below the lowest Bonneville bench level, bank height and steepness decrease, and the channel becomes less confined. This reach is completely within private property and was evaluated only in two locations where access was specifically permitted. In the areas assessed, the stream is channelized within artificially stabilized banks consisting of grouted rock walls, metal, or other hard structures. Fences commonly cross the stream at property lines, creating potential barriers to the transport of woody debris. As with reach LRB\_R09, springs occur within the reach and footbridges have been constructed in several locations. Vegetation conditions vary among properties depending on landscaping, with natural vegetation in some areas and mowed grass in other areas. Within the historic Garden Park Ward property, the creek flows through a constructed pond. Opportunities within this reach are limited by the urbanized hydrology, infrastructure constraints, and

“formal” landscaped use of streamside areas. Restoration of native shrubs, understory plants, and trees along the streambanks would improve the riparian functions of shading, filtration, and habitat in this reach.
